A Better City Feedback from the Field

The following recommendations and comments are based on observations from the field noted by the A Better City Transportation & Infrastructure team from **September 7, 2022, to September 8, 2022**. The intent is to support the MBTA and City of Boston in implementing continuous improvement during the Orange Line (OL)/Green Line (GL) shutdown as well as to ensure collection of data and information to allow for data-based assessment, real-time changes, and lessons learned.

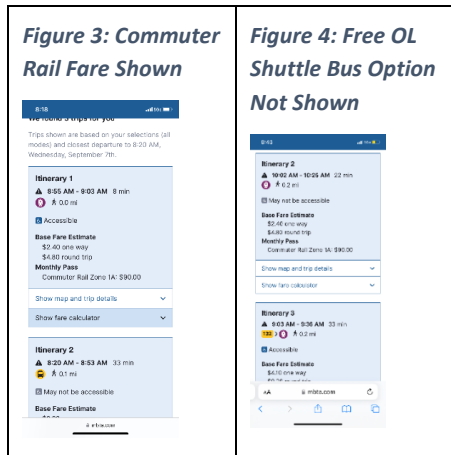
2. **Update MBTA Trip Planner to Show No Fare for Orange Line Shutdown Alternative Commuter Rail Service and Ensure Trip Planner Always Shows the Free Bus Shuttle Alternative.** The MBTA's online Trip Planner currently indicates a specific cost for the alternative commuter rail service (Figure 3) while at the same time shows there is no fare for alternative shuttle bus service. This likely deters riders from taking the Commuter Rail and benefitting from the related time savings. Further, in some scenarios, the MBTA Trip Planner does not show the free alternative shuttle bus service as one of the top options and suggests riders take a route that requires payment (Figure 4). Maximizing the number of riders on Commuter Rail should be a priority and making this change on Trip Planners as well as electronic signage in stations should encourage riders to take Commuter Rail.

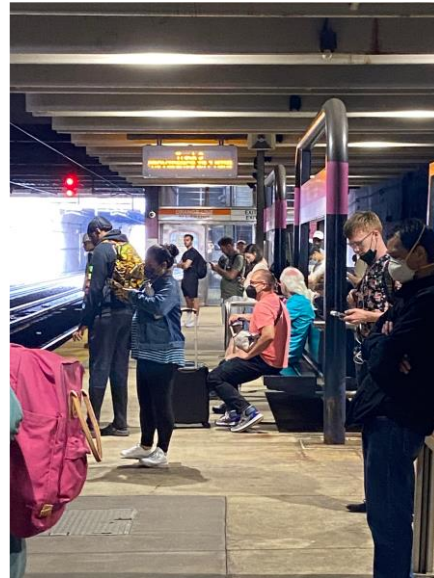
Figure 6: High Ridership Forest Hills Commuter Rail

- 4. Establish and Implement Process to Track Ridership on Alternative MBTA Shuttle Buses and Commuter Rail as well as Share Data with Public.** It is critical for short-, medium-, and long-term planning to track ridership on the alternative services (shuttle buses and commuter rail) provided by the MBTA during the Orange Line shutdown. With no accounting of bus shuttle ridership, it is impossible to assess if supply meets or exceeds demand as well as to understand the volume of ridership on this mode during the shutdown. Similarly, rider counts at rail stations not previously served by the Commuter Rail could help inform the popularity and value of this service on both the South and North sides, which could be viable and support increased Commuter Rail use post-shutdown. Anecdotal evidence suggests ridership is high (Figure 6 – above).
